Our File No.: 07-0674

VESSEL : M/V ISLANDER  
OFFICIAL NO. : 259789  
LENGTH : 191.7  
BREADTH : 58.1  
DEPTH : 14.8  
GROSS TONS : 855  
NET TONS : 581  
PROPULSION : Twin oil screw  
HORSEPOWER : 1800  
BUILT : 1950 / Baltimore, MD  
CAPACITY : 771 Passengers & 7 Crew

July 2, 2007  
File No.: 07-0674

*INTERNAL and  
ULTRA-SONIC INSPECTION  
REPORT  
on  
M/V ISLANDER*

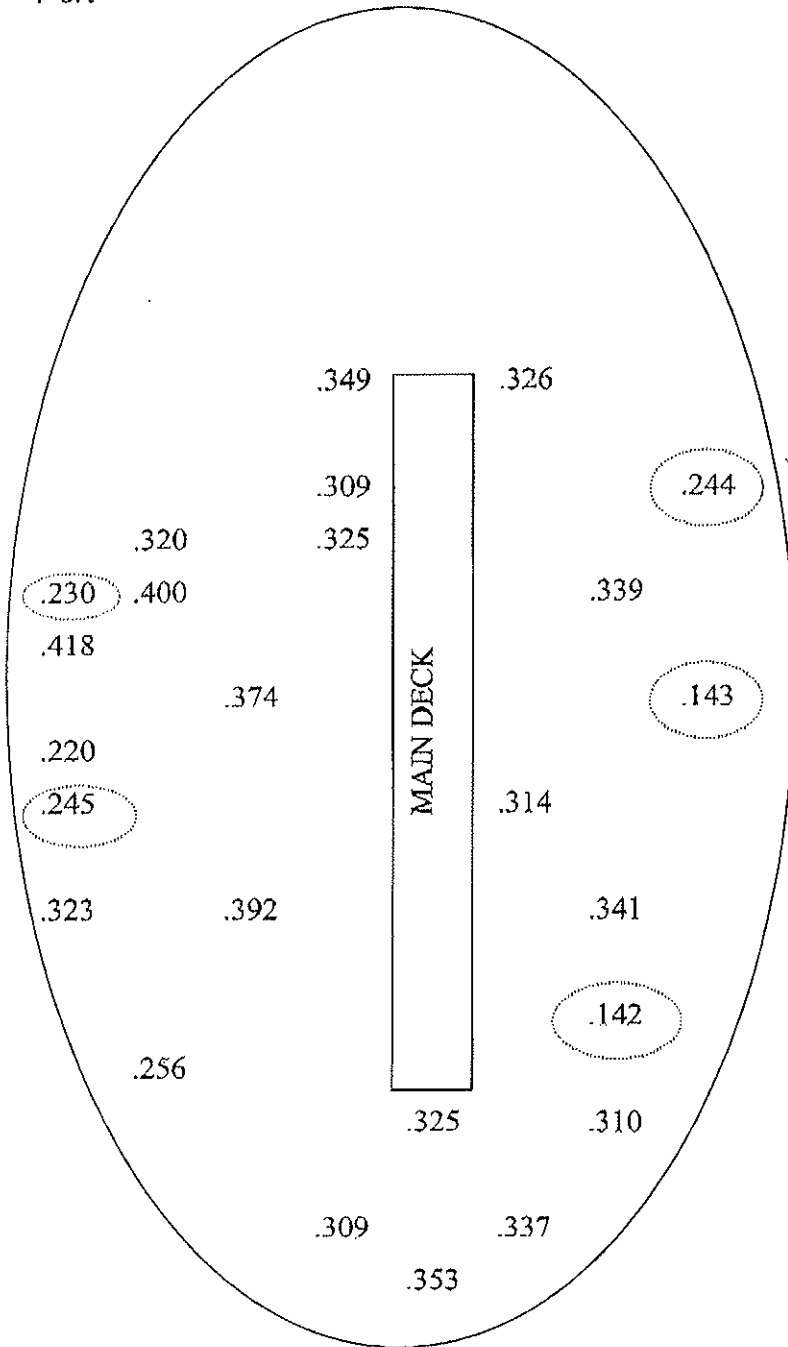
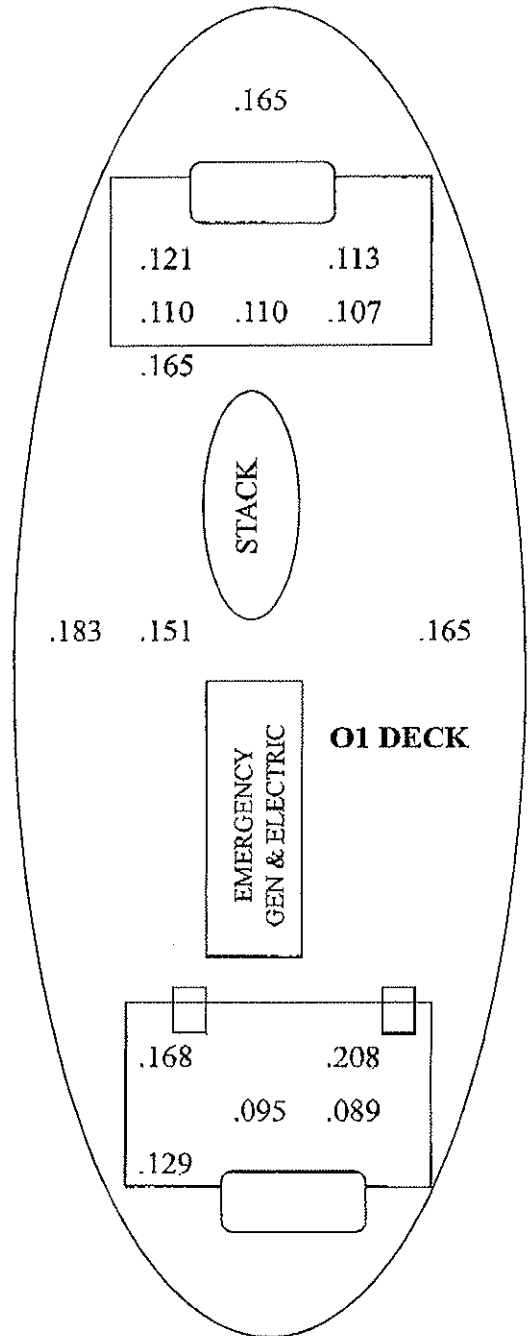
**Main Deck**

3. The overall condition of the main deck is fair, with paint coatings at approximately 80%. The deck has several areas of deep "dishing" that should be de-scaled, blasted to clean metal and re-inspected and cropped and renewed as necessary. The areas we noted as most problematic are outboard on both the port and starboard sides in the vicinity of ventilation ducts to below decks spaces and around deck fittings open to weather.

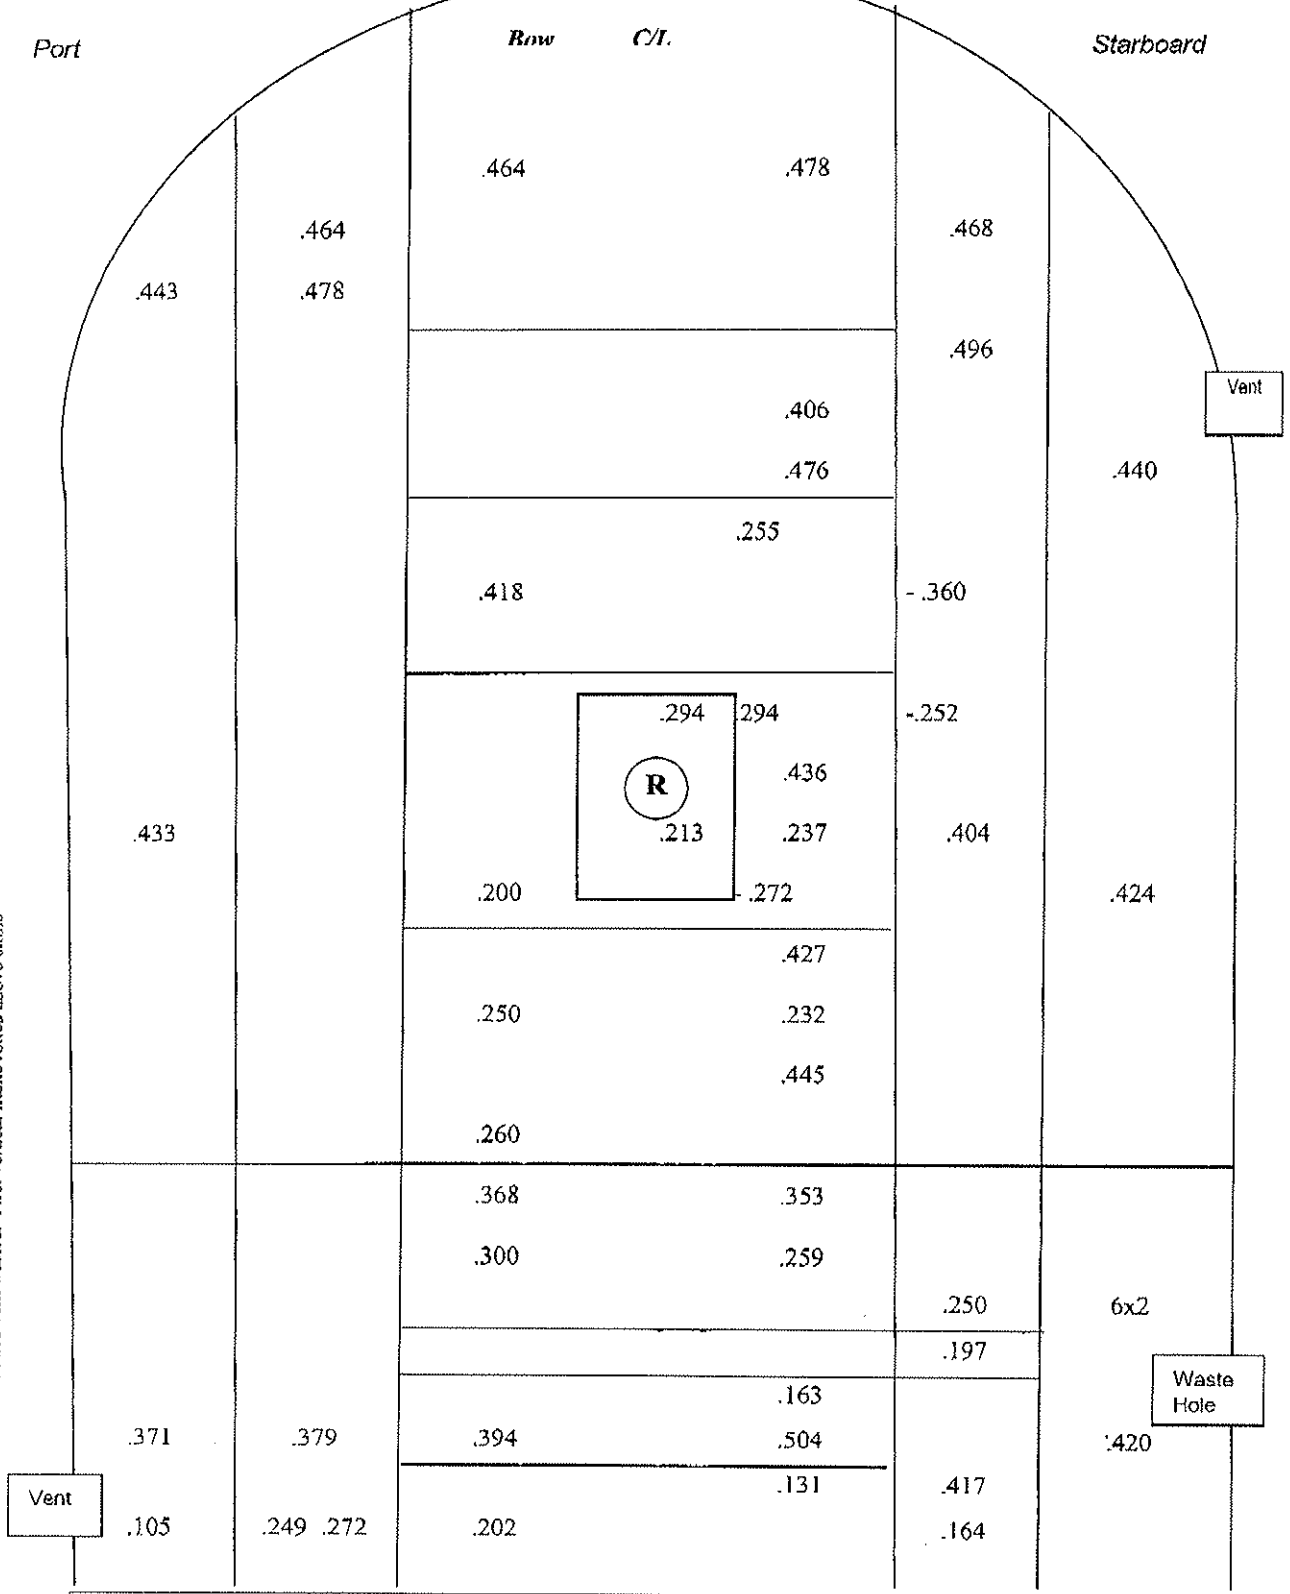
Forepeak

4. The 10<sup>th</sup> transverse frame is wasted on the first 2' of the inner end. **Crop and renew.**
5. The 11<sup>th</sup> and 12<sup>th</sup> bottom transverse frames are wasted 2' on the # 11 and 6' on the # 12. **Crop and renew.**

6. The aft bulkhead from the keel up 3' and all the way across is wasted more than 25%. **Crop and renew.**
7. Between the 3<sup>rd</sup> and 4<sup>th</sup> vertical frames on the starboard side, the overhead is wasted with noticeable water collecting on the deck. This is a vent area. **Crop and renew.**

8. The starboard side aft, at the vent on the deck, is wasted at the deck level. The upper hull plating in a 2' x 2' area and the transverse frames and stiffeners have heavy scale rust and wastage. **De-scale, re-inspect, crop and renew as necessary.**

9. The port side aft air vent is heavily wasted at the deck and to the lower hull plating and the transverse frames and stiffeners, and wasted on the upper hull above the chine line, is wasted through into the rub rail. **De-scale, crop and renew.**

10. The starboard side longitudinal bulkhead is wasted on the aft lower section, approximately 3' x 5' area. **Crop and renew.**

Deck areas around vent wasted. First vertical frame rotted above chline

NOTE: The void is in fair condition with coatings of approximately 50%. This void should be blasted and recoated to preserve the metal structure from further wastage.

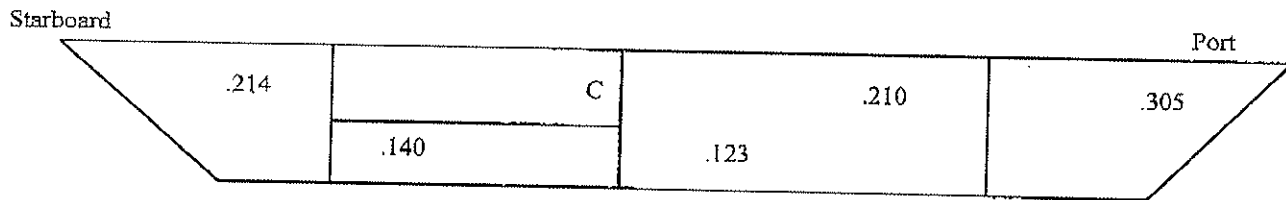
*Under Galley*

14. The port side, between the 4<sup>th</sup> transverse bottom frame to the 8<sup>th</sup> bottom transverse frame, and from the # 1 longitudinal to the weld line, an area approximately 4' x 7' is wasted more than 25%. **Crop and renew.**

15. The 1<sup>st</sup> through the 5<sup>th</sup> keel frames, wasted on the lower starboard half, approximately 2' x 4' area, these plates are 3/8" thick. **Crop and renew.**

16. The hull plating in the 1<sup>st</sup> bay, starboard side, from the weld line of the new plate to the keel, an area approximately 4' x 2' x 1/2" should be cropped and renewed.

17. The # 1 longitudinal on the starboard side is wasted between the 6<sup>th</sup> and 10<sup>th</sup> transverse frames, from the bottom to the weld line, approximately 6' long x 1' tall x 5/16" thick. **Crop and renew.**

18. The # 1 starboard bottom transverse frame is wasted on the lower 2' section. **Crop and renew.**
19. The lower hull plating, from the forward bulkhead to the 10<sup>th</sup> frame, is wasted, an area approximately from the keel 6' up and approximately 18' long. **Crop and renew.**

20. The # 1 port section transverse keel frame, an area approximately 2' x 4', should be cropped and renewed.

<i>Port</i>	<i>C/L</i>		<i>Starboard</i>
.429	.353 <i>wasted</i>	.274	.380
	.329 <i>wasted</i>	.401	New Plate
.431	.366	.366	
.428		.384	.410
	.225	.338	
.464 <i>pitting</i> <i>Heavy scale and rust</i>	.275	<i>Heavy scale and rust</i>	.513 .380 <i>Heavy pitting</i>
.293 .207 .251 .340 .412	.234		.401
.389 .293	.328		.510
.429   .386   X	.353	.457	.378 .238
.447 .386 .362	.326 .332	.425	.500 .368
	.411	.428	.399
		.430	.496
			.500

NOTE : The hull plating, where not replaced, shows heavy pitting and rust scale. The coatings are approximately 70% intact. The cutlass water feed line or stripping line for the tank had corrosion at several joints. These joints should be replaced.

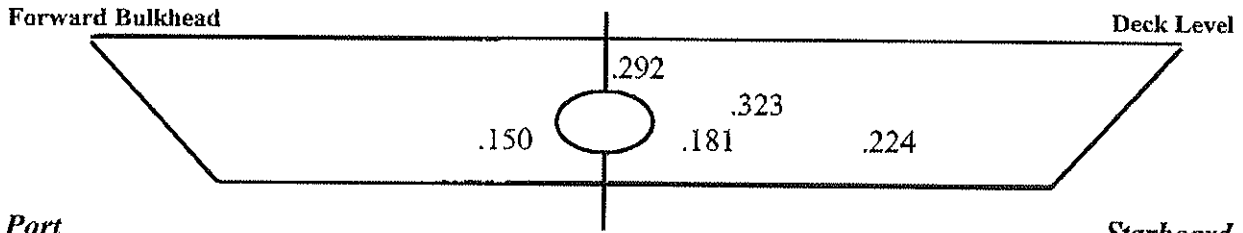
MSD SPACE FORWARD

21. Forward bulkhead, port and starboard side of keelson outboard 4' x 3' to 1<sup>st</sup> longitudinal to hull is wasted. **Crop and renew.**
22. 1<sup>st</sup> transverse frame from keelson to longitudinal on both port and starboard sides is wasted in a 4' x 3' area. **Crop and renew.**

23. 2<sup>nd</sup> transverse frame from keelson outboard to 1<sup>st</sup> longitudinal is 4' x 3' wasted area. **Crop and renew.**
24. 3<sup>rd</sup> transverse frame, starboard, from keelson to longitudinal. **Crop and renew.**

25. 1<sup>st</sup> longitudinal starboard side from forward bulkhead to frame 4, 7' x 3'. **Crop and renew.**
26. 1<sup>st</sup> longitudinal port side from bulkhead to 2<sup>nd</sup> frame, 4' x 3'. **Crop and renew.**

27. Forward bulkhead midship, deck level to hull outboard to starboard 12' x 8' centerline, holes and severe wastage. **Crop and renew.**
28. Frames 6 - 10 starboard sides are buckled from keelson outboard to 4', 4' x 3' areas. **Crop and renew.**

29. Frame 3 port, keelson to under tank. **Crop and renew.**
30. Port side forward, 96 sq. ft. bottom. **Crop and renew.**
31. Adjacent to centerline keelson, 84 sq. ft. bottom plate. **Crop and renew.**

32. Adjacent to centerline keelson, four (4) 8' x 3" x 5" angle iron. **Crop and renew.**
33. Adjacent to centerline keelson, one (1) 5' x 24" flange plate. **Crop and renew.**

34. Port side forward, 56 sq. ft. bottom plate. **Crop and renew.**
35. Outboard # 2 longitudinal, two (2) 10' 3" x 5" angle iron. **Crop and renew.**
36. Outboard # 2 longitudinal, 8' x 12" flange plate. **Crop and renew.**

NOTE : The overall condition of this space is poor below the deck. Extensive wasted transverse framing, wasted forward bulkhead from deck level to hull, along with deteriorated hull plating beneath the sewage tanks require crop and renew to approximately 30% of this space. Paint coatings above deck level and outboard of the third longitudinal appear well bonded.

1	.336	.418	.344		.313 Wasted	.379		
	.440		.54	.504				
2			.362	.507	.451	.415		
			.364	.384				
3		.406			.443	.403		
			.328			.462		
4				.170				
		.402	.288	X	X	tank		
5	.436		.384	X	X	.248		
	.414		.320	X	X			
6	.322		.286	X <i>ballast</i>	X	Set up		
			.260	X	X			
7			.150	X	X	Set up		
	.436		.318	X	X			
8			.210	X	X			
			.262	X	X			
9			.178	X	X	Set up		
			.316					
10	.198	.338	.346			Set up		
	.320	.360	.448

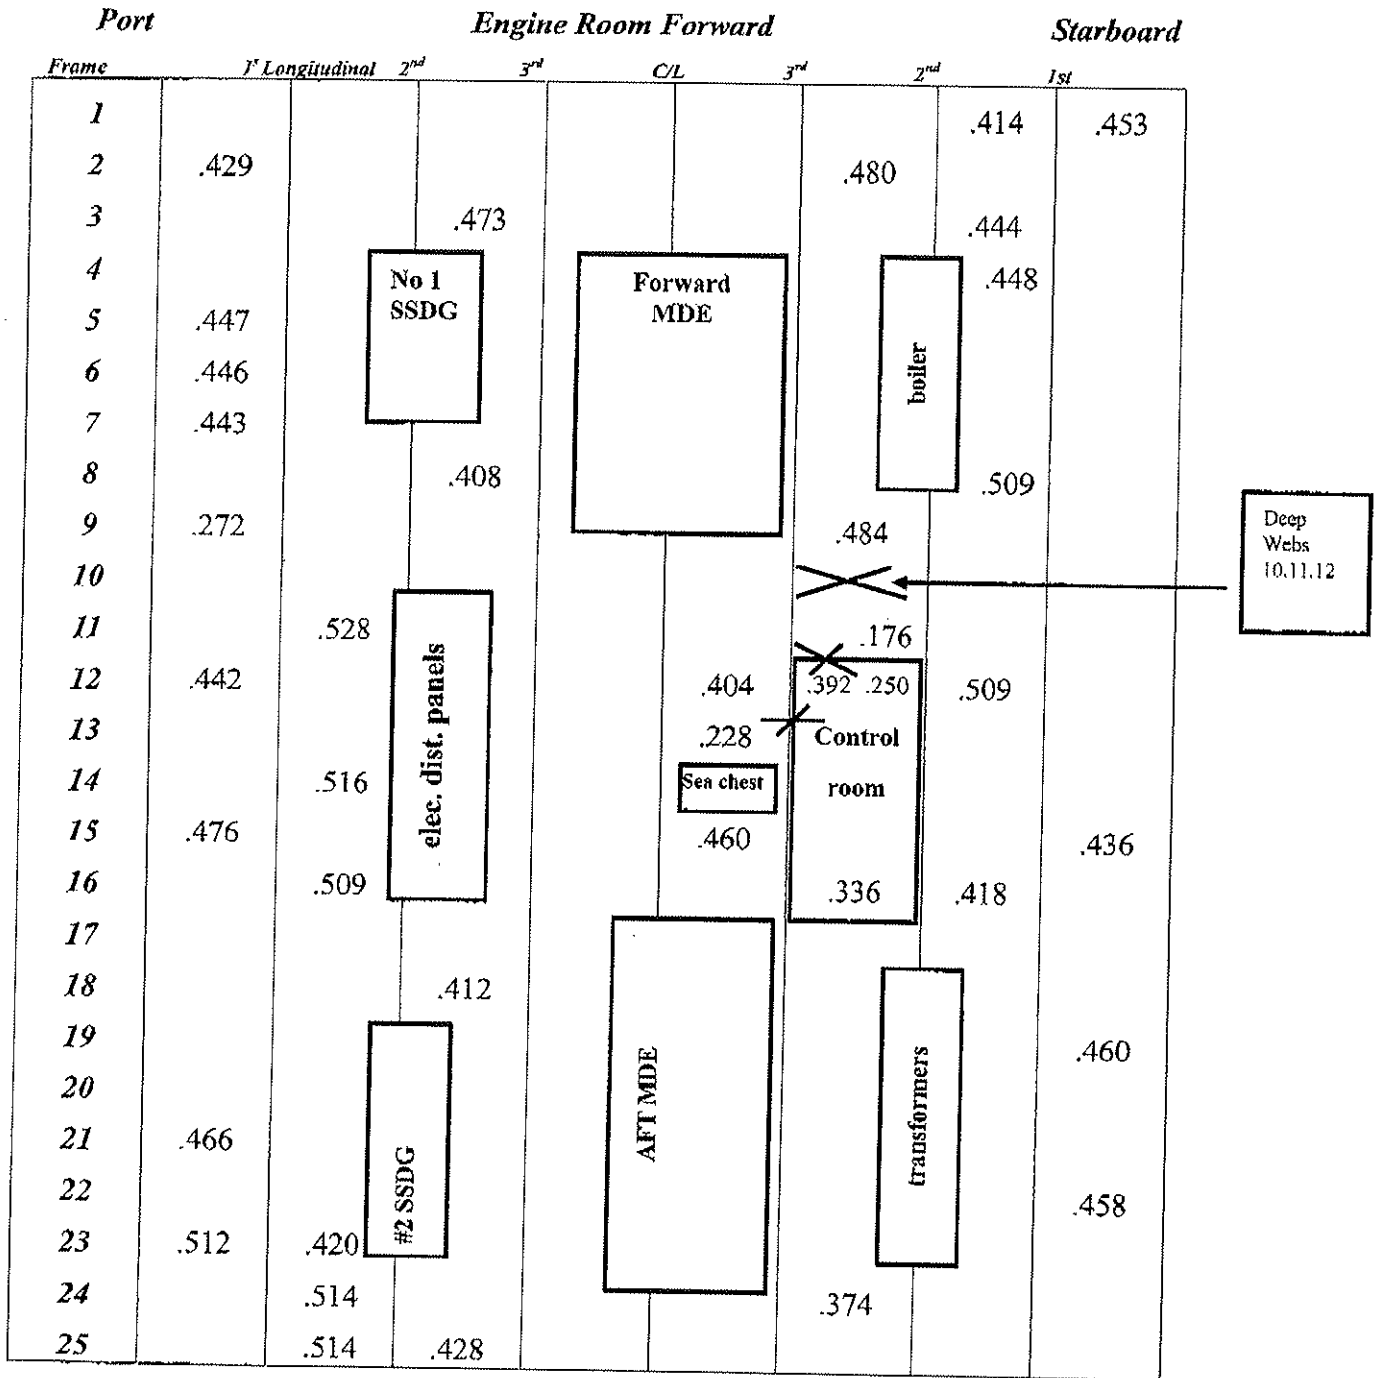
37. Starboard sea chest, starboard side, frame 12, ½" plate. **Crop and renew.**
38. Starboard side, below longitudinal # 12, deep webs 10, 11, 12, 13, and 14 at 8' each x 24" flange plate. **Crop and renew.**
39. Bottom plate 20 sq. ft. between frames. **Crop and renew.**
40. Lower frames 11, 12 at 6' each, 3" x 5" angle irons. **Crop and renew.**

NOTE : The overall condition of the Engine Room space is considered good with paint coatings well bonded at approximately 95%. It was reported by the maintenance crews of the Steamship Authority that at the last major dry dock period, hull plating and frames in approximately 50% of the space were renewed. We found the areas around the starboard sea chest to have low readings and recommend a closer inspection to this area by deck plate removal, de-scaling to bare metal and re-gauging to determine the amount of waste incurred. Many areas beneath the deck plates were inaccessible, but were observed visually and appeared to have recent work and well bonded paint coatings.
